# Plugable TBT4-UDZ firmware update procedure

The following procedure describes how to update the Realtek DisplayPort MST hub firmware within a Plugable TBT4-UDZ docking station using a Windows host PC

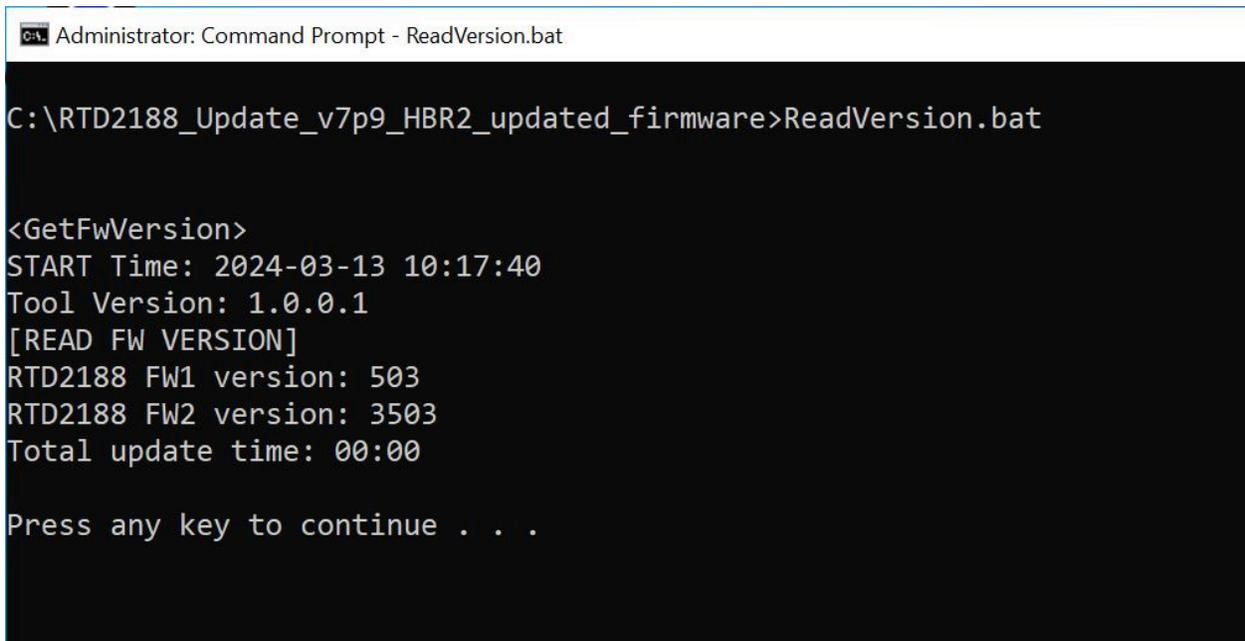
7. The 'ReadVersion.bat' file will detect the presence of the TBT4-UDZ dock, and if detected will report success in reading the internal firmware versions, similar to the example below:

```
Administrator: Command Prompt - ReadVersion.bat

C:\RTD2188_Update_v7p9_HBR2_updated_firmware>ReadVersion.bat
